RE: Progress report for February 2006 activities - Hecla Mining Company Apex Site (EPA ID No. UT982589848, Docket No. RCRA-8-99-06)

MEMORANDUM TO: Paul Glader
COPIES TO: file, distribution
FROM: Chris Gypton
SUBJECT: **Progress Report No. 22 for period ending February 28, 2006; Pond 2 Final Closure - Apex Site, Washington County, Utah**

Annual Site Inspection Summary Sheet - Apex Site - Pond 2

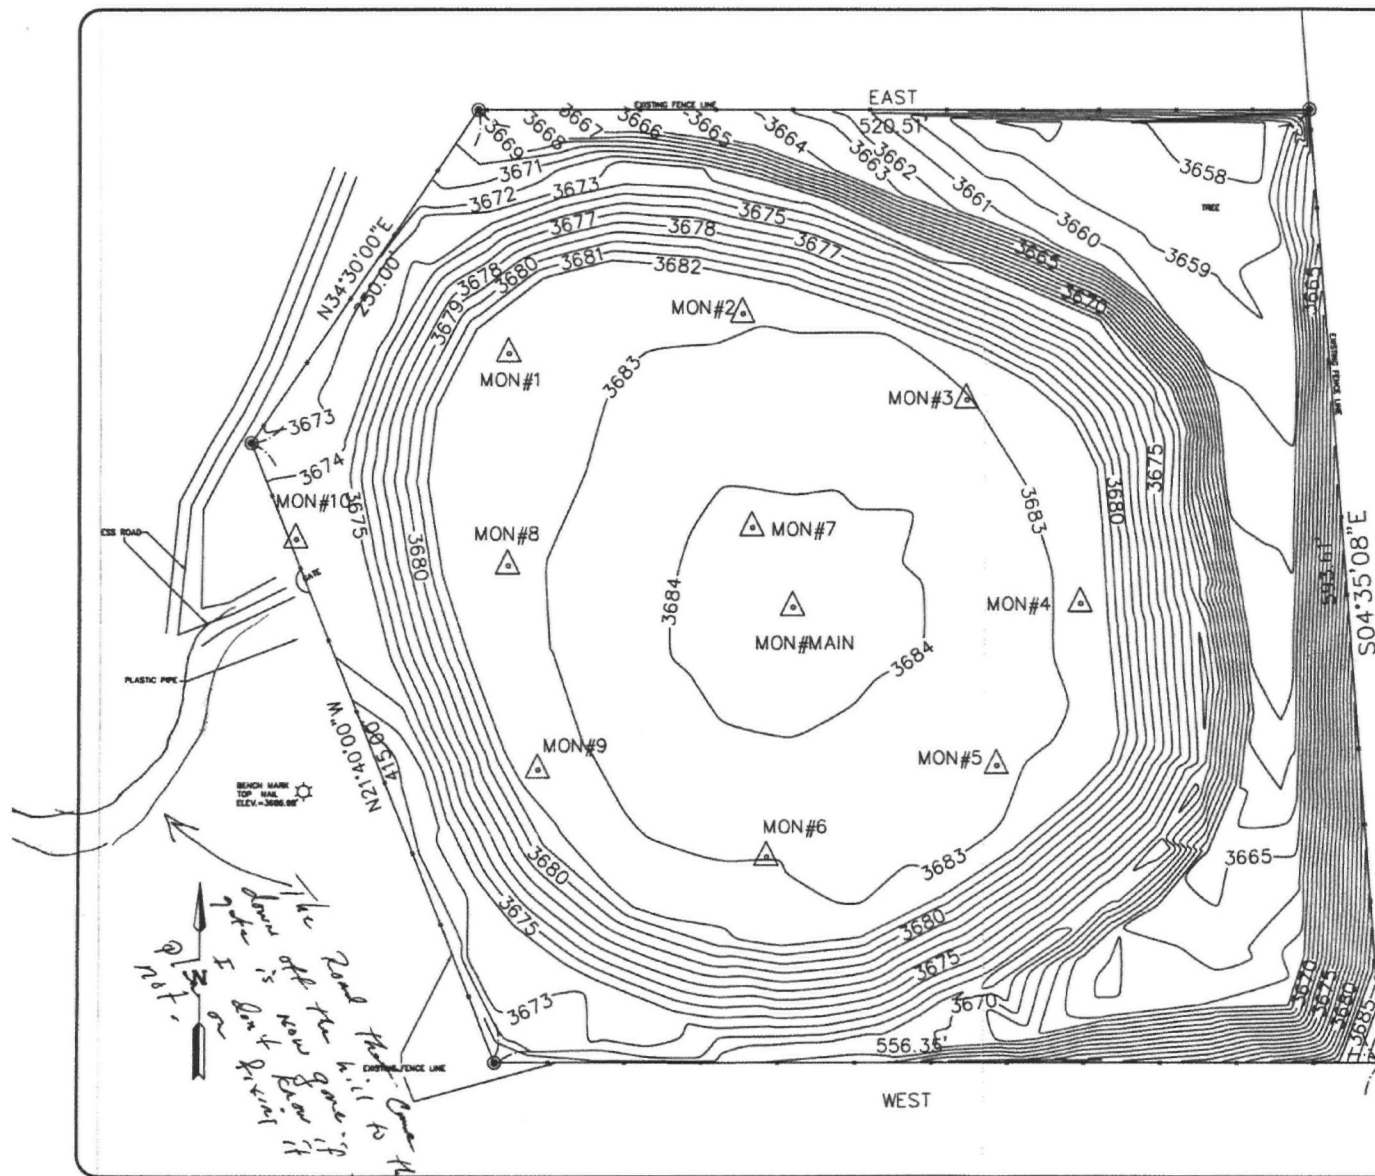
DATE	20 Feb. 06
DRAWN BY	S. Thomas
CHECKED BY	C. Gypson
SCALE	1" = 70'
POND 2 FINAL CLOSURE APEX SITE	
WASHINGTON COUNTY UTAH	
Hecla MINING COMPANY	
FIGURE NO. 1

SITE INSPECTION

Inspector: *Don Thomas*

Inspection Date: *2/14/06*
